Application Guide

UTILITY BOILERS - OIL/GAS FIRED

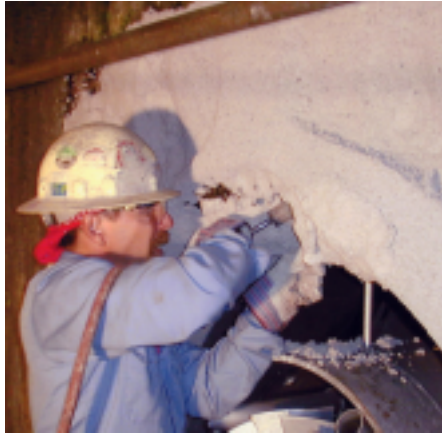
Furnace Floor

- Normal Service*
- Plicast Tuff Mix
- High Duty Service*
- Plicast KL 3000
- Severe Service*
- Plicast HyMOR 3100 Special
- Plibrico 68S A

Tangent Tube (backup)

- Normal Service*
- Plicast Airlite
- High Duty Service*
- Plicast LWI 20
- Severe Service*
- Plicast Trowl Mix Plus KK
- Plisulate 1900 Block

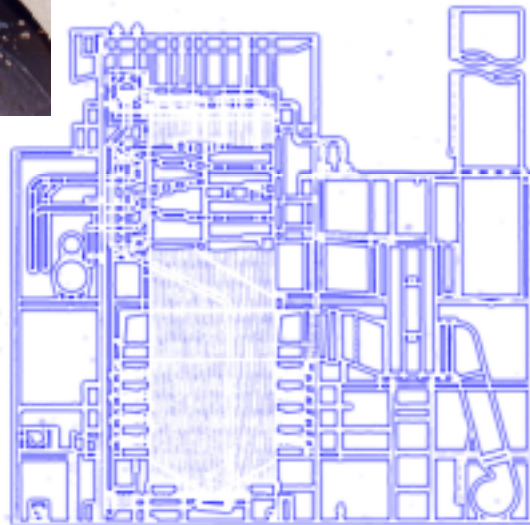
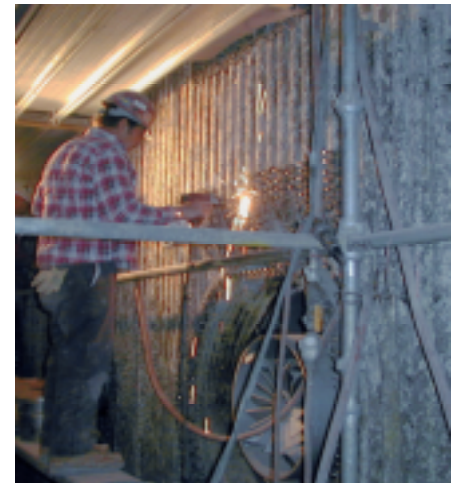
Application Note

Heat Recovery Steam Generators (HRSG)

Problem—Deterioration of ceramic fiber insulation between steel liner layers in the exhaust gas stack resulting in shell hot spots.

Solution—Insulation injection repair with:

- Plistix Injectite 2300
- Pligun Verilite (pumped)
